NASA TN D-7143

# APOLLO EXPERIENCE REPORT - DESCENT PROPULSION SYSTEM

*by William R. Hammock, Jr., Eldon C. Currie,  
and Arlie E. Fisher*

*Manned Spacecraft Center  
Houston, Texas 77058*

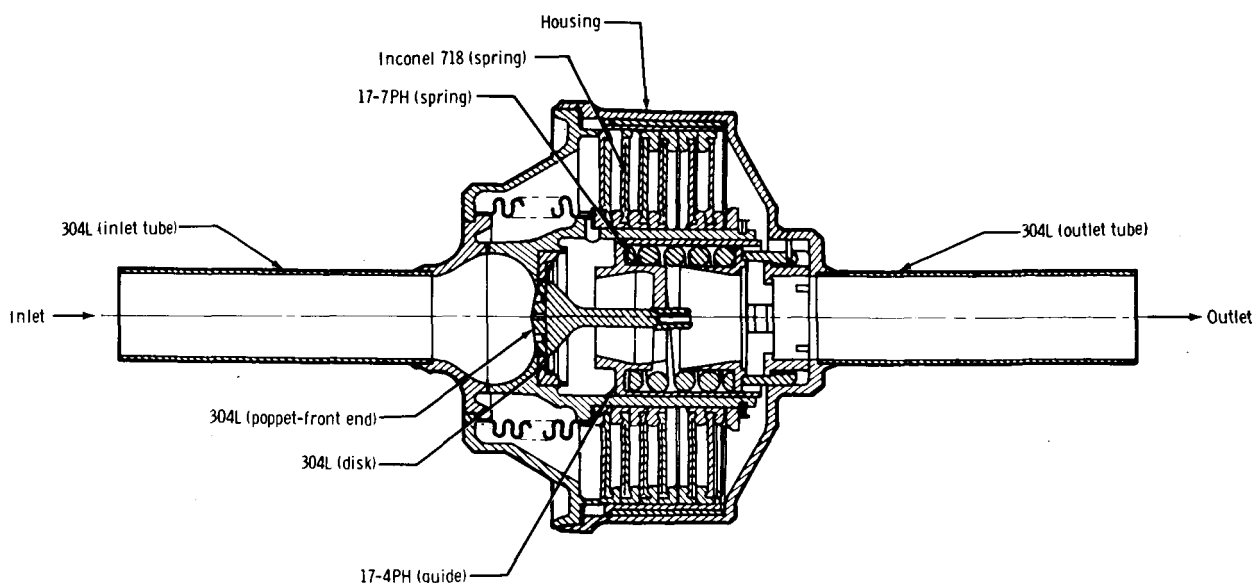
Figure 5. - The new burst-disk assembly.

A newly designed burst disk (fig. 5) with a burst-pressure setting of  $267.5 \pm 7.5$  psia was selected to improve the design safety margins and pressure-cycling limitations on the propellant tanks. Another desirable feature of the newly designed burst disk was the ability to withstand

reverse-pressure differentials (approximately 150 psid) without incurring damage. Before selection of the new design, many failures of the old burst disk occurred in checkout as a result of inadvertent reverse pressure.

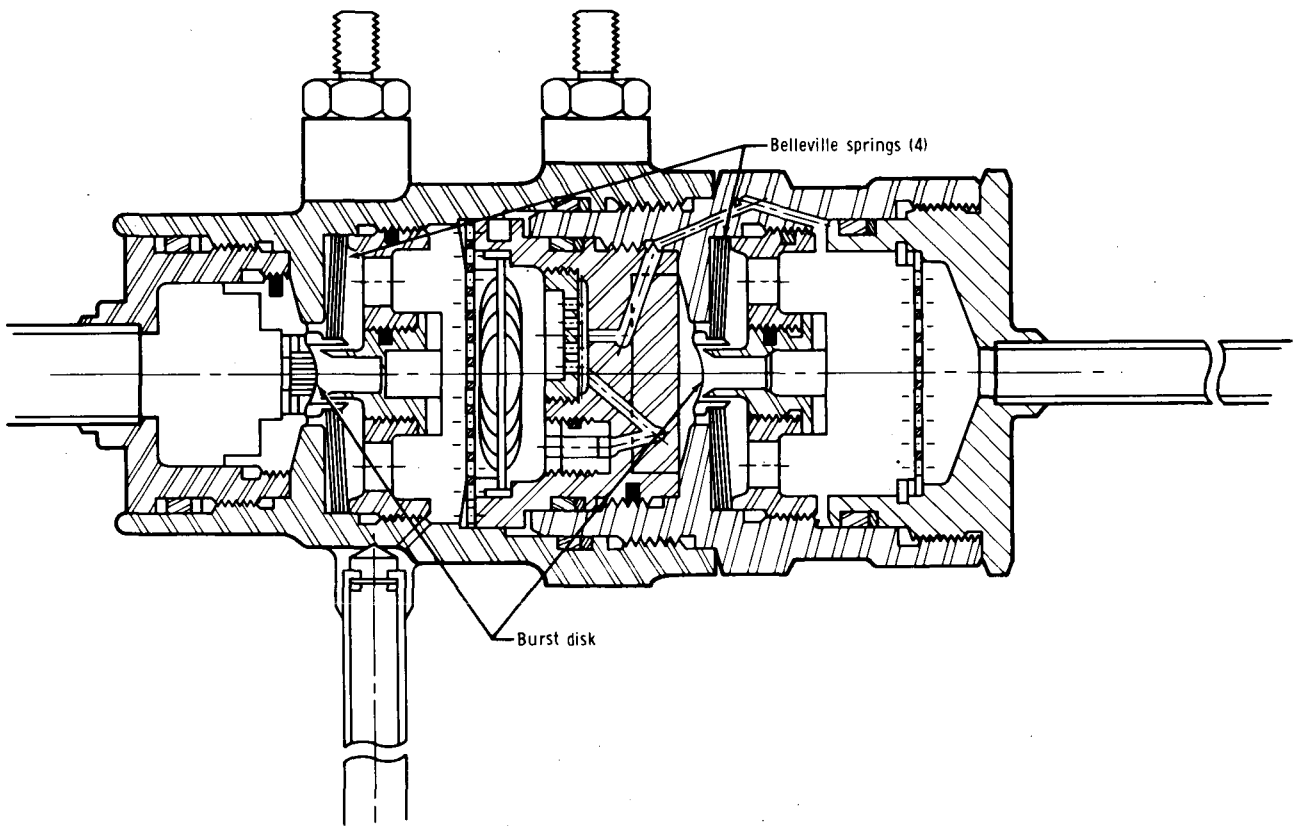
Figure 8. - The SHe tank burst disk.

The dual burst-disk assembly on the SHe tank was designed with stainless-steel belleville washer springs (17-7 PH) that controlled the burst-pressure setting of the burst disk. During certain vehicle checks on an SHe tank, the primary disk ruptured at approximately 300 psi below the set pressure of 1881 to 1967 psia. This rupture was traced to stress corrosion of the belleville springs caused by long-term exposure to moisture. One spring of the four-spring stack was cracked completely through; thus, the preload on the burst disk (fig. 8) was lowered. If moisture was detected by a vacuum-dryness check, a pressure-proof test was performed on all production burst disks. Also, desiccant bags were maintained on the outlet tube of all burst disks after the dryness check and the pressure-proof test. Subsequent to LM-5 (Apollo 11), on some vehicles the burst disk was modified to incorporate an Inconel belleville spring, which is resistant to stress corrosion.

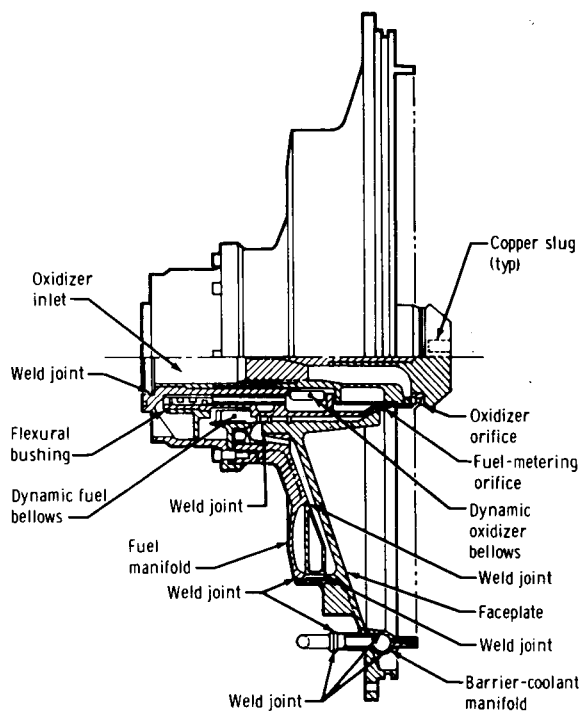
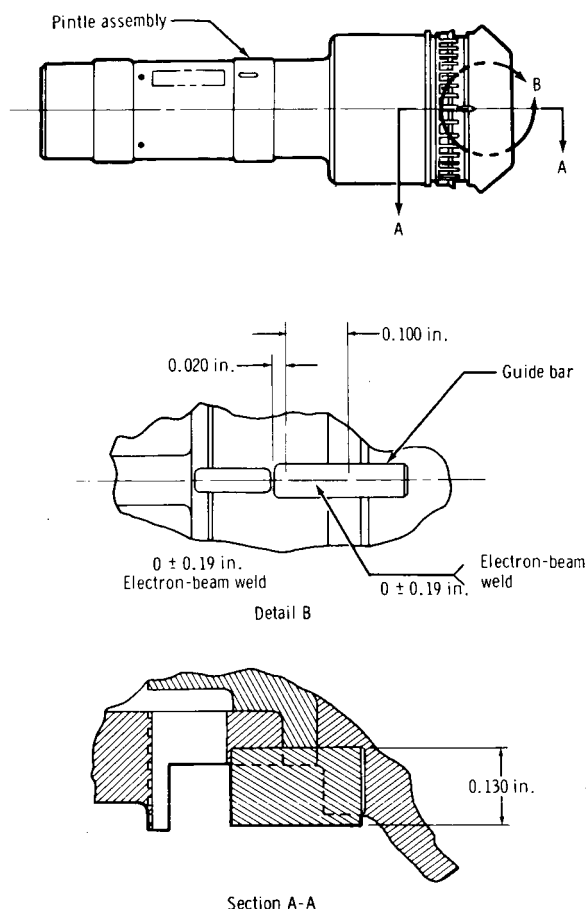
Figure 10. - Pintle-assembly diagram showing guide-bar installation.

The original injector pintle tip (figs. 9 and 10) was made of stainless steel, and it incurred severe erosion during engine operation because of inadequate cooling. As a result of the erosion, copper slugs were incorporated in the pintle tip to promote better

During the phase-B qualification test, gouging did occur on one engine. The gouging was traced to one of the fuel-barrier cooling orifices being plugged by room-temperature vulcanized (RTV) rubber, which was used as a seal around the tubes of the cooling orifice at the ablative faceplate. A process change was made to prevent plugging of the fuel-barrier cooling orifices during assembly. Also, during the phase-B qualification test, one engine incurred a failure of the electron-beam (EB) weld on the guide bar that positions the oxidizer sealing ring (fig. 10). This failure also occurred on several WSTF engines, and in some cases, the guide bar came completely out from under the oxidizer sleeve. Subsequently, an EB tack weld in the center of the guide bar was changed to a structural EB weld around the periphery of the guide bar.

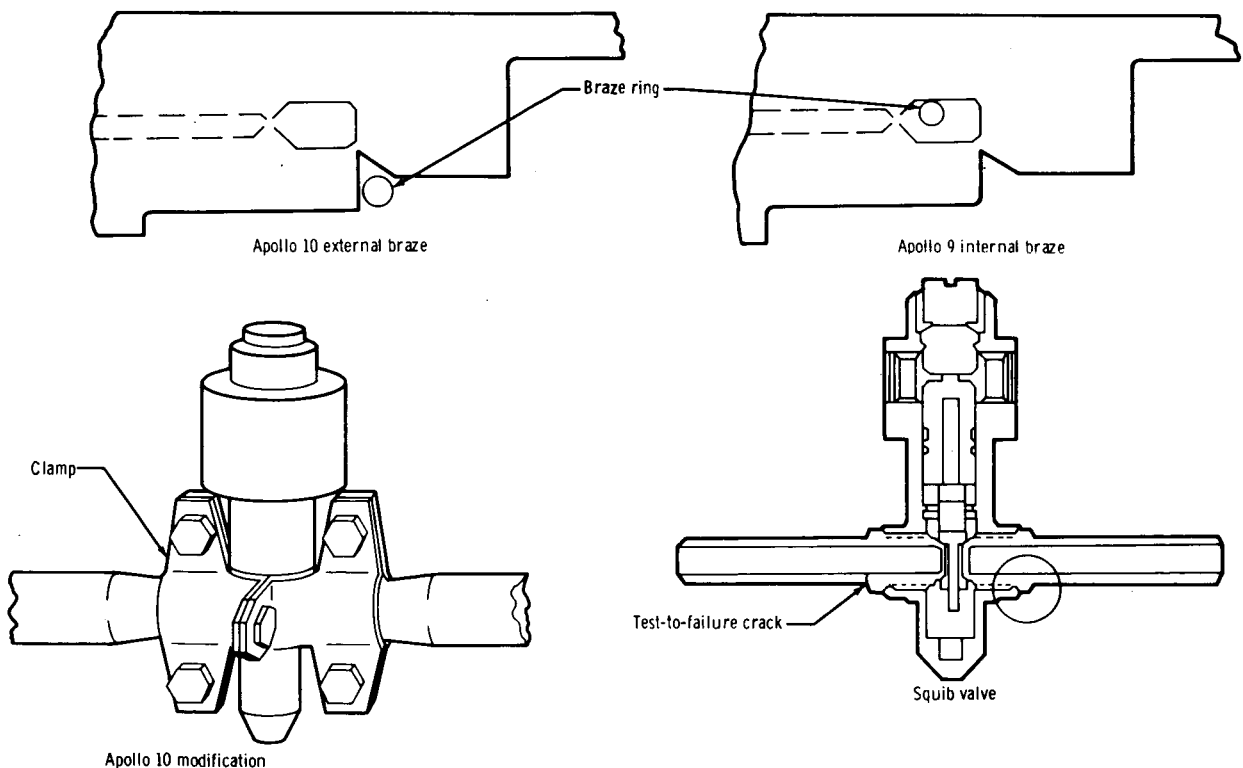
Figure 14. - The SHe squib-valve configuration.

The LM-3 SHe squib valve was similar to the LM-2 squib valve in that the valve fittings were internally brazed, which prevented inspection of the joint. The leak experienced during Apollo 9 probably was caused by a defective braze that was internal to the squib valve and could not be inspected.

The mission criticality of external leakage was evaluated for each of the squib valves on the Apollo 10 vehicle. On the DPS, the oxidizer-compatibility squib valve was determined to be of the internal-braze configuration; thus, if external leakage developed, it could have been hazardous to the mission. Therefore, this valve was modified to incorporate RTV potting reinforced with an external clamp (fig. 14) to contain any leakage if the brazes cracked. This configuration was thoroughly tested before the flight. The valves on all vehicles subsequent to Apollo 10 were of the external-braze configuration.

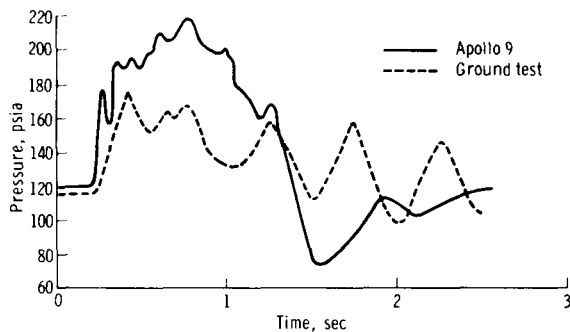
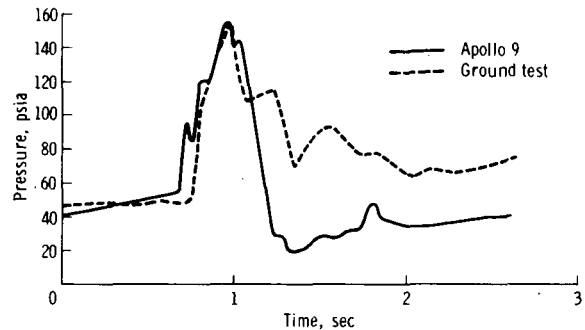
Figure 15.- Comparison of roughness during second descent-engine firing and ground test.

Engine roughness: During the second descent-engine firing, rough combustion was encountered at approximately 27-percent thrust as the engine was being manually throttled from 12 to 40 percent. This roughness lasted for approximately 2.5 seconds, during which time the crew delayed increasing the throttle. The resultant transients in propellant-injector pressures and chamber pressure are shown in figure 15.

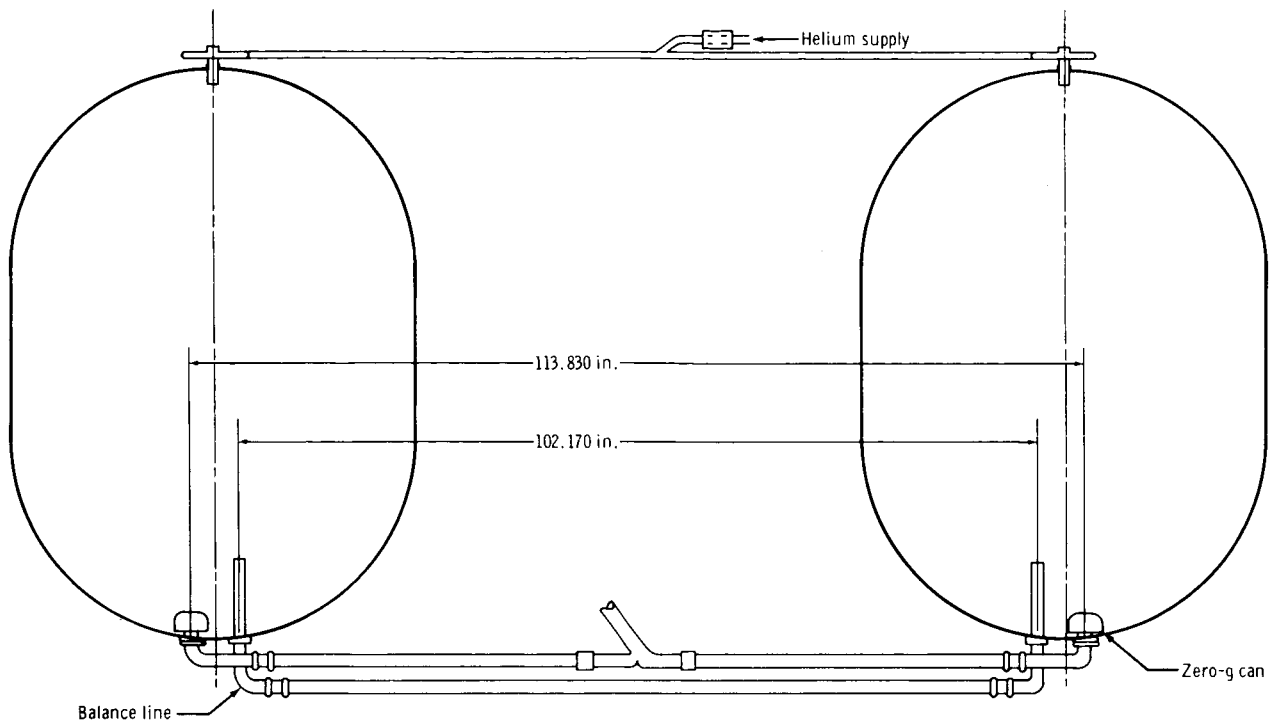
Figure 16. - Tanks and plumbing of the DPS.

that the zero-g-can retention screen was not capable of holding propellants at the 114-inch head between identical propellant tanks (fig. 16).

Helium ingestion requires that the zero-g can be uncovered and that lateral or rotational accelerations be present. This condition was highly probable with the 60-percent ullage volume present in Apollo 9 propellant tanks before the second descent-engine firing. Tests have demonstrated that ingestion of helium into the engine in this manner has no detrimental effect on the system.

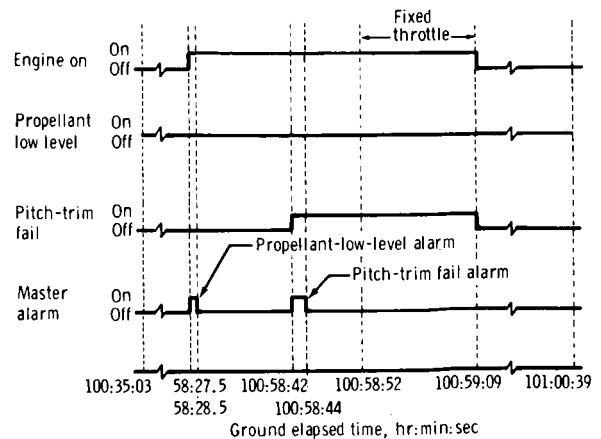
Figure 17. - Master alarms during Apollo 10 phasing maneuver.

The low-level indication probably was caused by a gas bubble in the unsettled propellant uncovering the low-level sensor before the burn but after turning on the PQGS. Once the low-level sensor was uncovered, the indication was latched on by a latching relay and remained on until the PQGS was turned off again after completion of the burn. The crew display of low quantity was inhibited until the engine "on" command was given, thus explaining the master alarm at the time of engine ignition. This

fact was verified by the telemetry recording of the low-level indication during the phasing burn (fig. 17). The second alarm (immediately after throttle up) could not be verified by telemetry data nor explained by normal system operation. On subsequent missions, the low-level indication was removed from the master alarm because a visual indication by the low-level warning light was considered adequate warning for the crew. Also, if the low-level indication occurred at engine ignition, a contingency crew procedure was instituted to reset the low-level indication by cycling the PQGS off and on.

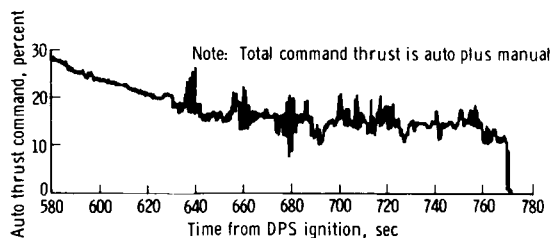
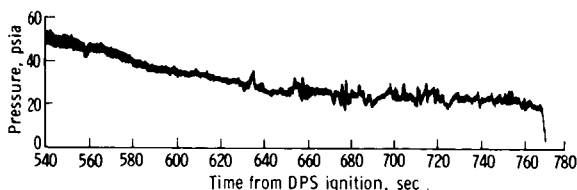
Figure 18. - Apollo 11 hover-phase throttle profile.

During the last 140 seconds of the PDI burn (hover phase), a series of large oscillating-throttle changes occurred (fig. 18). These changes were approximately 15 percent peak-to-peak about a nominal throttle setting of approximately 26 percent. Large and rapid changes in vehicle attitude (as much as  $15^\circ$  at  $10^\circ/\text{sec}$ ) in pitch during the final phases of landing caused centrifugal accelerations on the inertial-measurement-unit accelerometers located at the top of the ascent stage high above the vehicle c.g., thereby giving a false indication of vertical acceleration. This false indication caused the lunar guidance computer to command a throttle change to compensate for an unreal change in vertical acceleration. Later, this problem was investigated under the analysis of the guidance and control system.

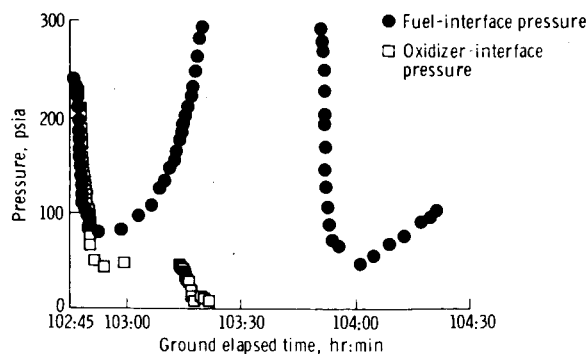
Figure 20. - The Apollo 11 descent-propellant and helium venting.

Venting of the propellant and the SHe tanks after lunar landing resulted in the freezing of the fuel-to-helium heat exchanger. Fuel and oxidizer interface pressures as compared to time during the postlanding venting are presented in figure 20. Venting of the SHe tank through the lunar-dump valves resulted in the flow of residual cold helium into the SHe tank through the heat exchanger, thereby freezing the fuel in the fuel passages and blocking flow of fuel through the heat exchanger. During the subsequent hour, the engine experienced a peak in heat soakback from the ablative chamber, which caused the fuel trapped

in the line between the heat exchanger and engine SOV to expand thermally; therefore, the pressure rose rapidly. After 30 minutes, the fuel pressure was relieved by thawing of the heat exchanger, failure of the line-bellows linkage, or failure of the seals in the pre valve. The exact cause of relief was not determined. On subsequent flights, the venting procedure was modified to isolate the SHe tank by the latching solenoid valves during venting of the propellant tanks and to delay SHe venting until immediately before launch from the lunar surface. Based on autoignition tests of the fuel at various pressure levels, the final-vent fuel-pressure level was revised from 20 to 40 psia to 8 psia to prevent any autoignition hazards in the aerazine-50 fuel during engine peak periods of heat soakback. On LM-7 and subsequent vehicles, a bypass line around the heat exchanger was incorporated as an added safety feature to relieve the trapped fuel pressure if freezing of the heat exchanger should occur.
