NASA TN D-7143

# APOLLO EXPERIENCE REPORT - DESCENT PROPULSION SYSTEM

*by William R. Hammock, Jr., Eldon C. Currie,  
and Arlie E. Fisher*

*Manned Spacecraft Center  
Houston, Texas 77058*

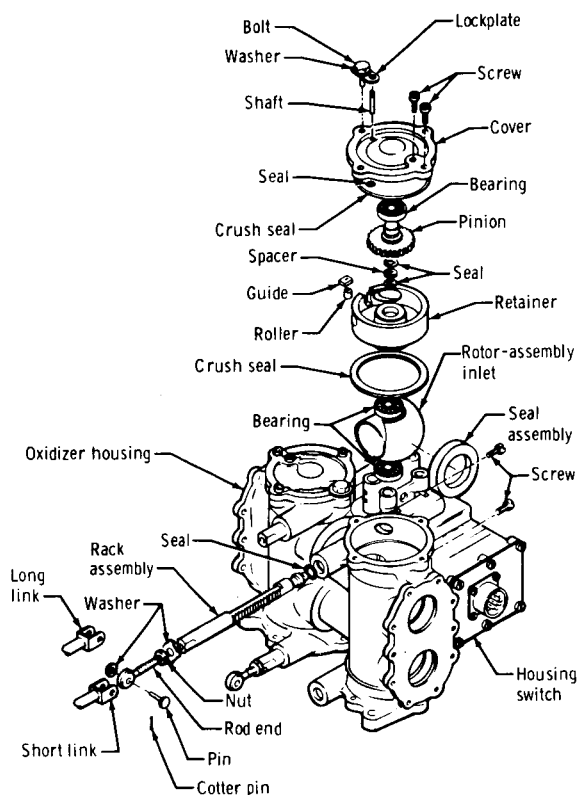
Figure 11. - Exploded view of oxidizer section of engine shutoff valve.

In the testing of developmental and WSTF engines, several instances of rack jamming or sluggish valve actuation occurred. This problem was caused by oxidizer leakage past the shaft seals (fig. 11) into the gear cavities and by subsequent reaction of the oxidizer with the gear lubricant. No cases occurred where the valve completely jammed, but all cases resulted in sluggish valve actuation on the affected rack. The gear cavities on all flight engines were checked for leaks and acidity (pH factor) before delivery. Also, a force-pressure check to detect sluggish valves was performed at the plant of the contractor and at the NASA John F. Kennedy Space Center to measure the pressure for cracking and full-open actuation of each of the four actuators.

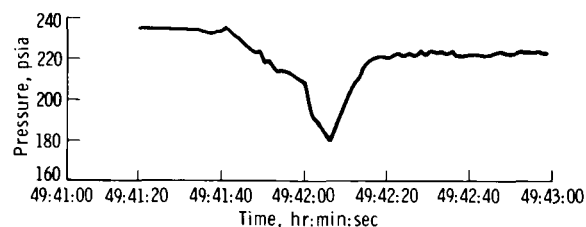
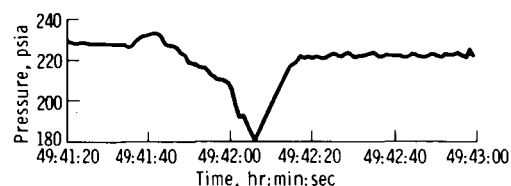
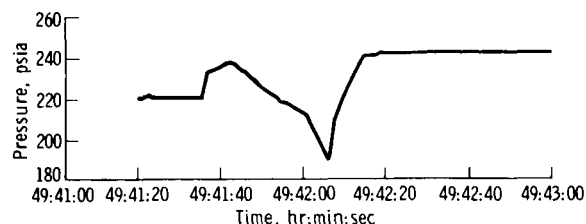
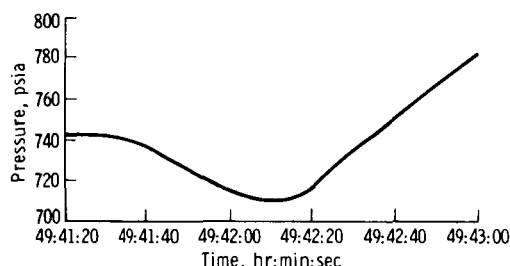
Figure 13. - Apollo 9 DPS pressures during start of first firing.

The SHe tank internal-heat-exchanger freezing: During the first 35 seconds of the first descent-engine firing, the regulator outlet-manifold pressure decreased from 235 to 188 psia. The regulator should have regulated at 247 psia (fig. 13). The
